# Manhole Inspection Summary

Manhole # S47E\_\_037MH

Insp Date: **7/28/08 8:15 AM**

**Location** Address: **Baltimore**

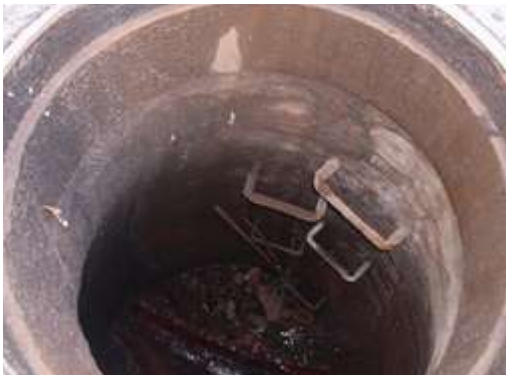
Defect 1

☒ **Leaks**

frame leaks

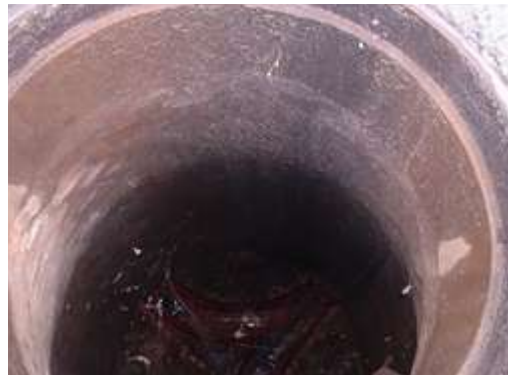
Defect 2

Infiltration: ☐ None ☐ Joint ☐ Cracks ☐ Mortar ☐ Roots ☒ **Wall**

infiltration

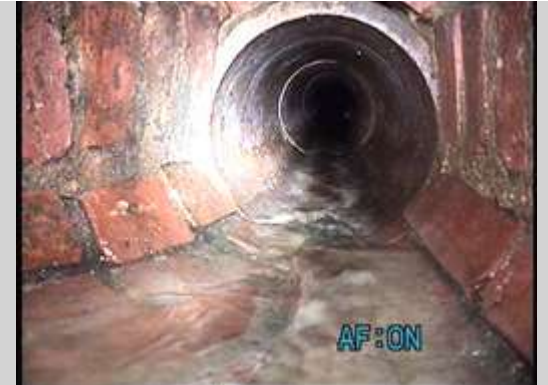
12 O'Clock Outflow

Pipe Height: **8.4** (in.) Rod and Bar (Angled)  
Pipe Material: **Clay** ☐ Pipe Lined  
Invert Depth: **9.70** (ft.) Flow Characteristics: **None**  
Deposits: ☒ None ☐ Mud ☐ Sludge ☐ Debris ☐ Grease  
Silt Depth: (in.) Deposits Extent:  
Infiltration: **None** Pipe Seal Cond: **Sound**

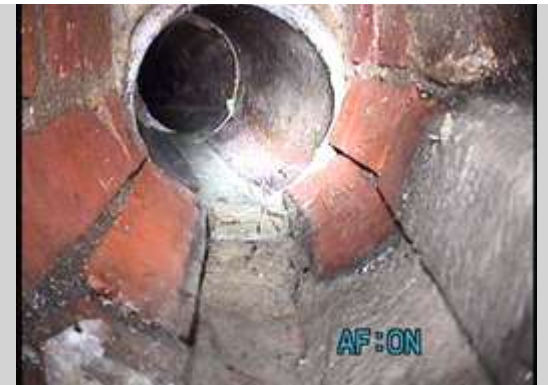
5 O'Clock Inflow

Pipe Height: **6** (in.) Rod and Bar (Angled)  
Pipe Material: **Clay** ☐ Pipe Lined  
Invert Depth: **9.50** (ft.) Flow Characteristics: **None**  
Deposits: ☒ None ☐ Mud ☐ Sludge ☐ Debris ☐ Grease  
Silt Depth: (in.) Deposits Extent:  
Infiltration: **None** Pipe Seal Cond: **Sound**

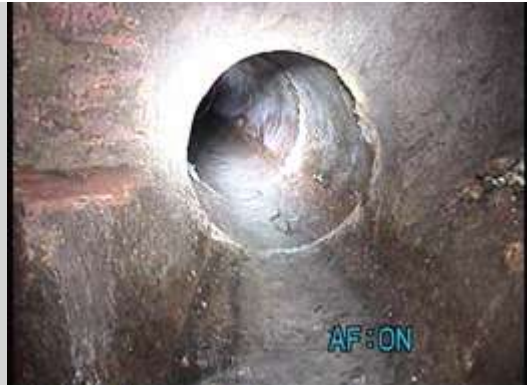
6 O'Clock Inflow

Pipe Height: **6** (in.) Rod and Bar (Angled)

Infiltration: **None**

Pipe Seal Cond: **Sound**

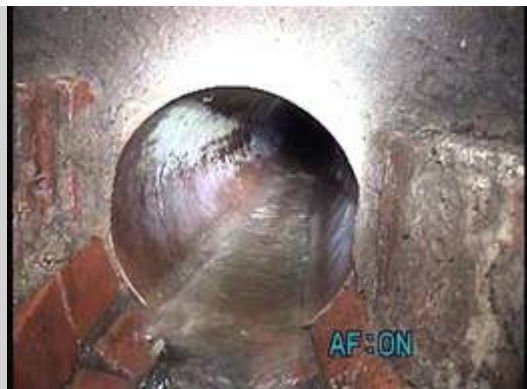
9 O'Clock Inflow

Pipe Height: **8.4** (in.) Rod and Bar (Angled)

Infiltration: **None**

Pipe Seal Cond: **Sound**
